**Inspection corroded sheet piles
Heerema Vlissingen B.V.**

In 2005, Acotec coated a part of the sheet piles at Heerema Vlissingen B.V. The aim of the inspection in 2014 was to determine the effectiveness of the coating after ten years and to inspect the condition of the sheet piles.

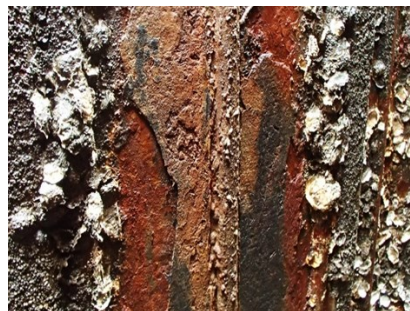
Scaling in the splash zone

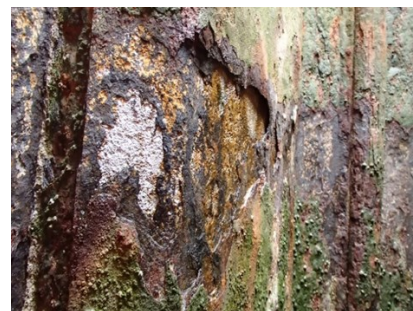
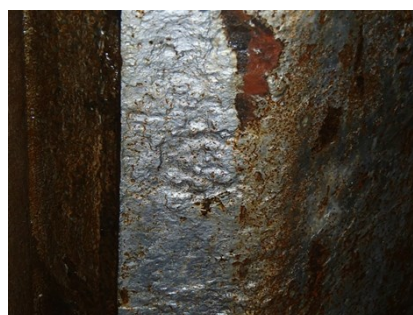
The inspections of the non-protected sheet piles showed corrosion both below and above the waterline. MIC caused pitting resulting in perforations of the sheet piles.

Pitting due to MIC in submerged zone

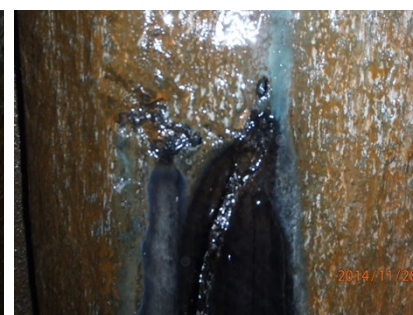
Perforation due to MIC in submerged zone

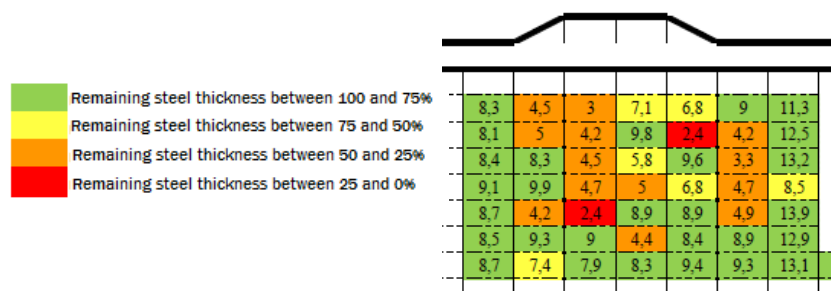
Example of chart: remaining steel thickness

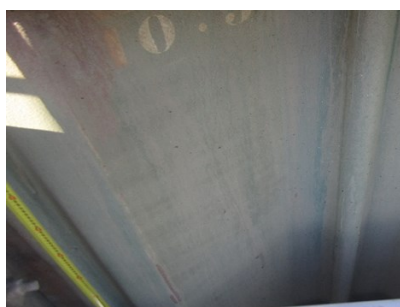
The inspection of the ten-year old coating showed that the coating is still intact and performs well. No corrosion was detected at these places.

Coating still performs after 10 years
