**Talisman Energy—TLM Claymore platform  
Onsite Repair of nodes**

After inspection of the Claymore Jacket Center Line, it was concluded that two nodes needed coating repairs. The primerless one-coat Humidur® system was determined to be the best solution.

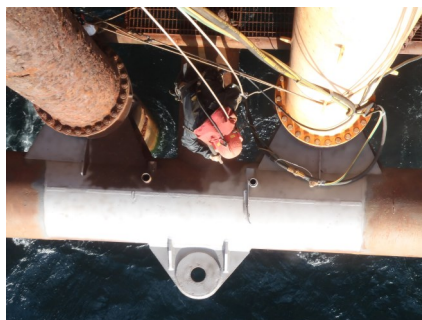
Abrasive blasting by rope-access
