A revolutionary coating repair system

Humidur anti-corrosion coatings

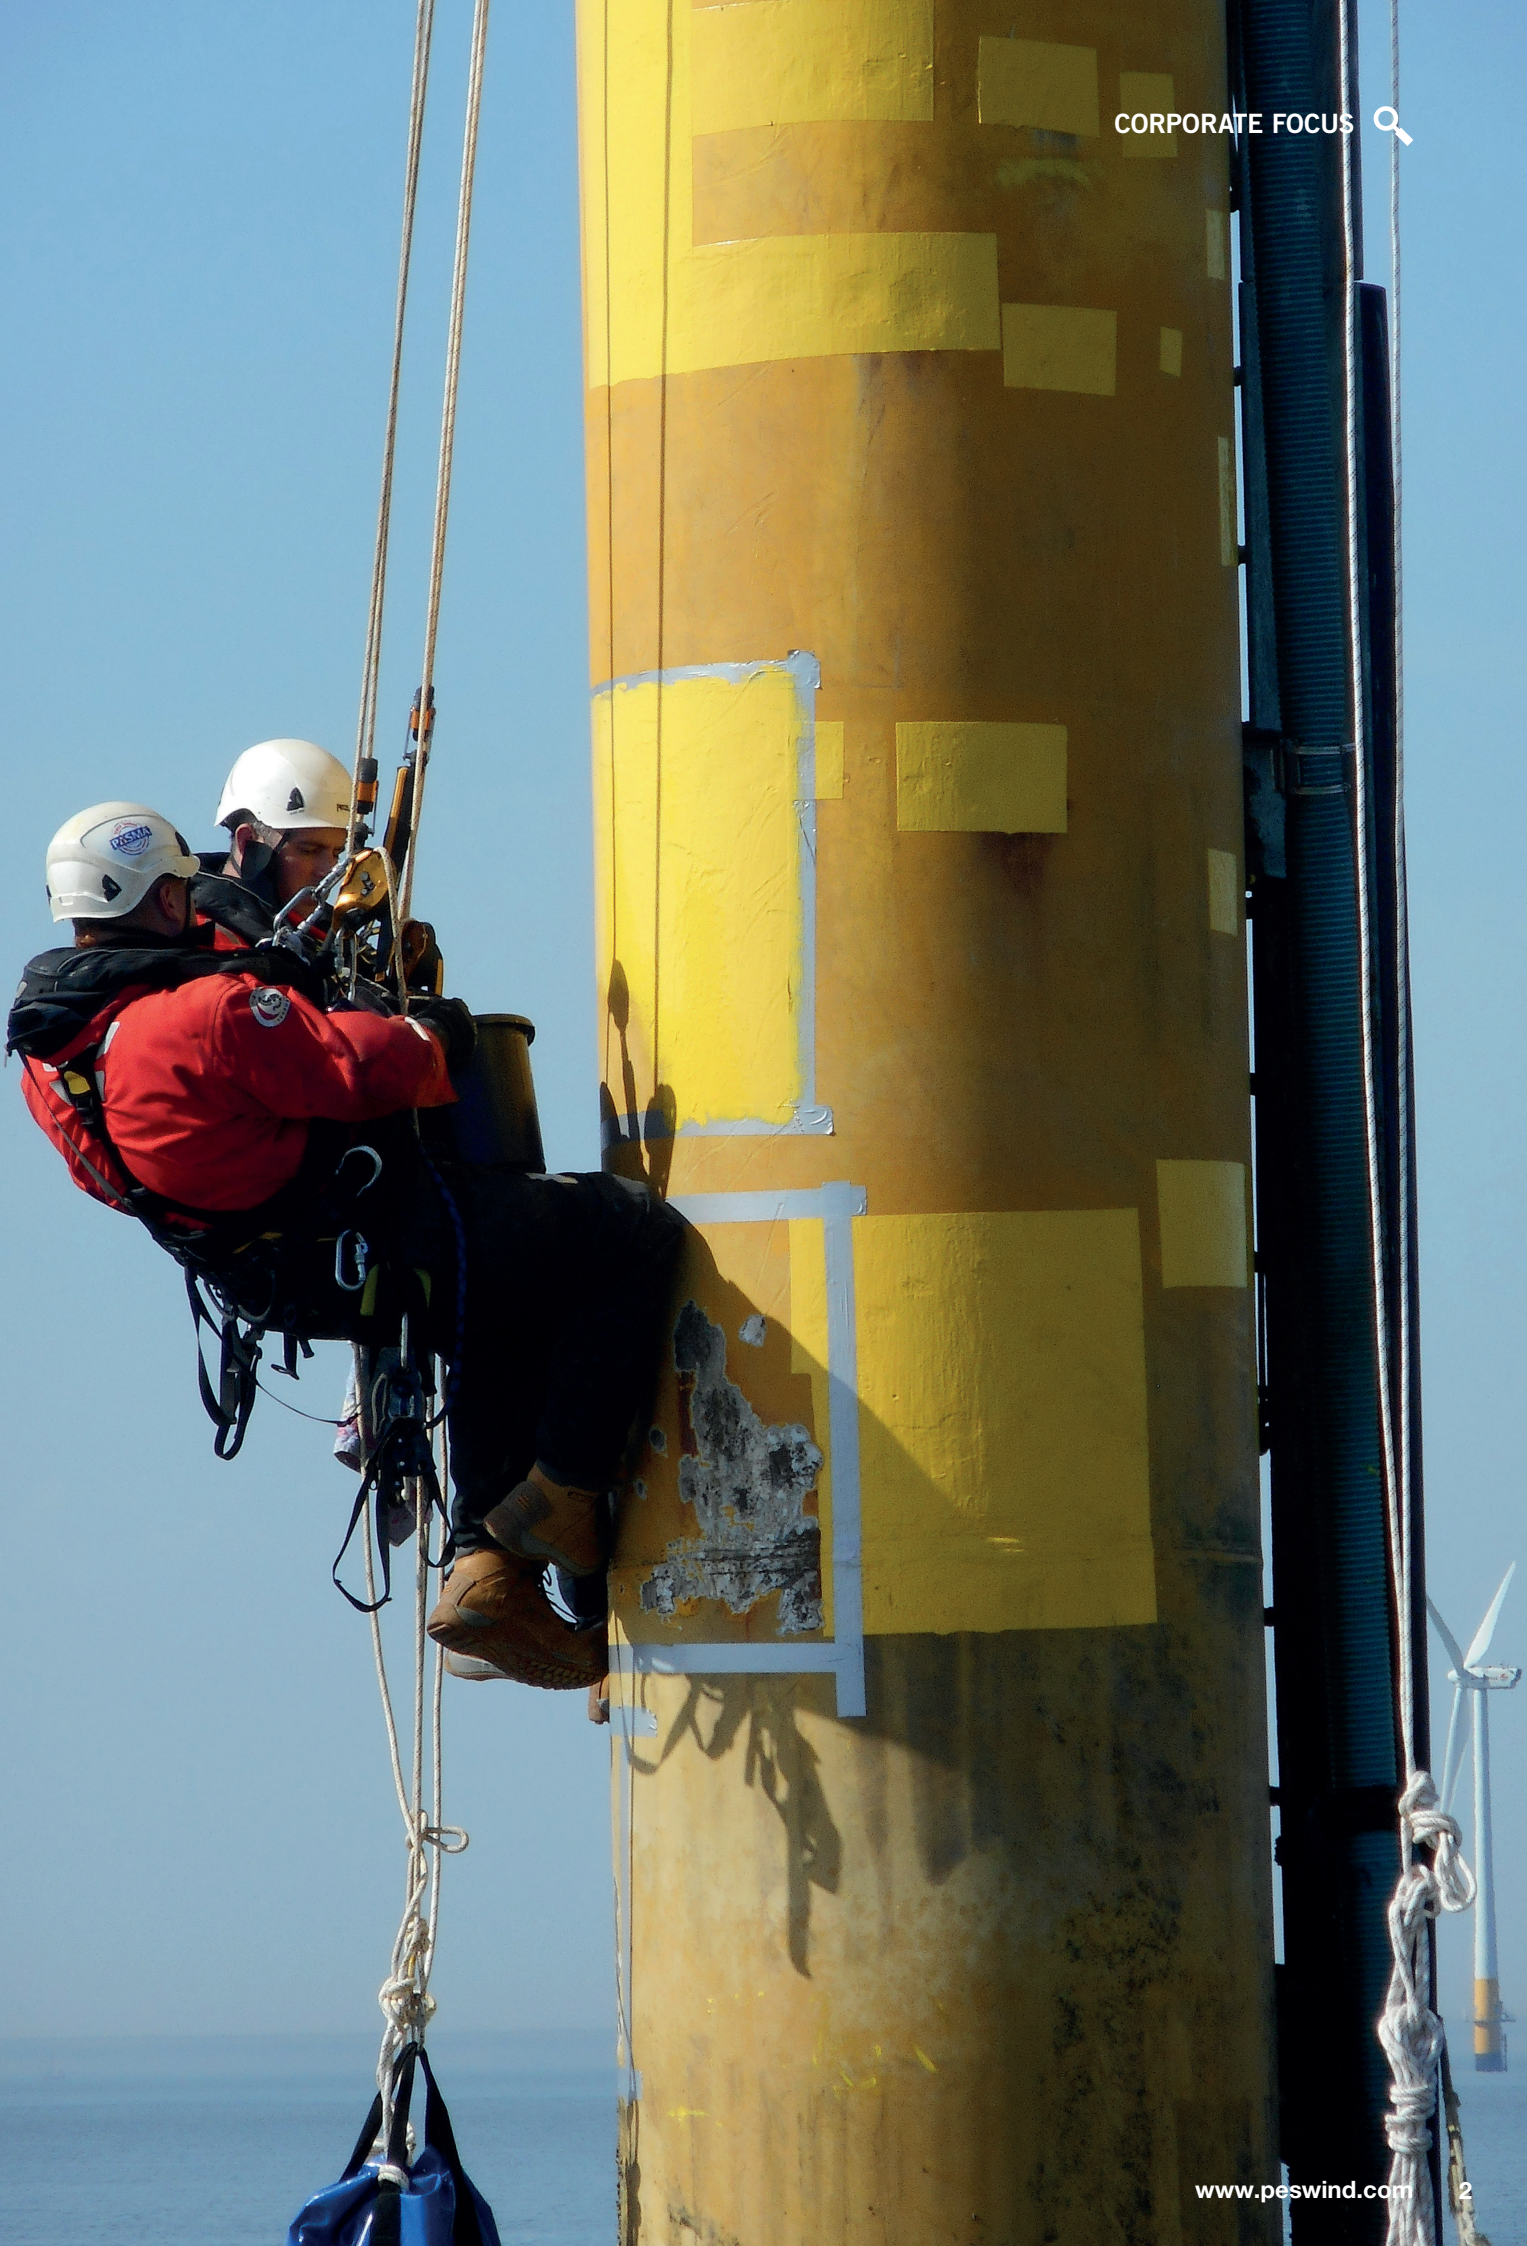
As can be seen in the image, the grey coating does not withstand the abrading action exposing the steel to seawater. This shows the importance of selecting the right coating system. The reason of failure could be any of following factors or a combination.

The most straightforward explanation is that the coating does not offer sufficient abrasion resistance to withstand the forces

applied on the boat landings. As the boat landings are in the splash zone/tidal zone and come into contact with water, another plausible cause is that the chosen system is not able to cure correctly due to water or at high humidity. Another factor to take into account is the performance of the coating system on minimally prepared surfaces.

Nevertheless, this coating offers a high quality finish on these boat landings because of its high abrasion resistance and because it can be applied at high humidity. Furthermore, it cures under water disregarding its salinity without sacrificing any of its quality.

The inspection of the boat landings after 2 years proves the superiority of Humidur in these conditions. Visually the coating does not show any degradation.

DFT measurements were carried out and showed no decrease in thickness. In other words, the abrading action does not result in coating loss.

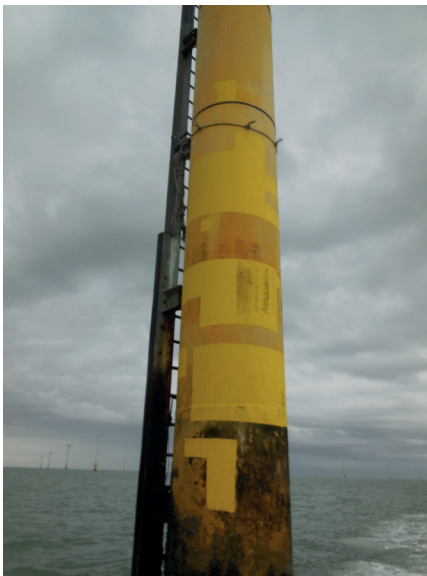
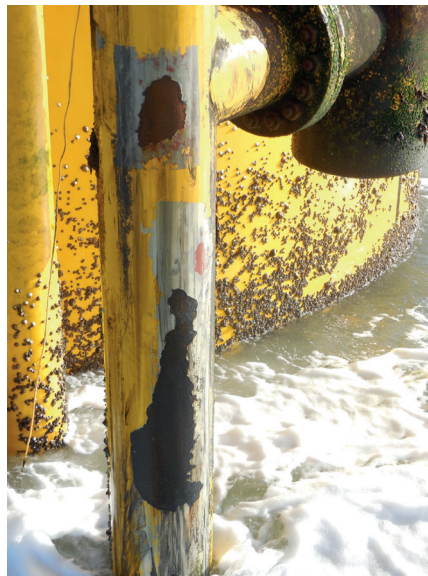
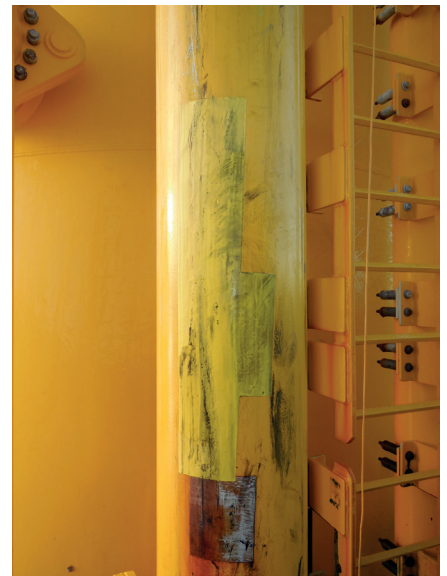
The coating is applied in one yellow layer, by brush at a thickness of 400 µm. The thickness during application is checked with WFT gauges. As the coating is a solvent-free system, the wet film thickness equals the dry film thickness.

Immediately after surface preparation the coating is applied. The coating is supplied in 1 kg sets. This allows the applicator to proceed easily by rope-access. The sets are simply mixed by pouring pail B into pail A and mixing it. No thinners, which have an adverse effect on the environment, are necessary.
