## Hallett Dock—Duluth

Acotec nv

In 2015, 1,200 feet (360 m) of severely corroded steel sheet pile wall was rehabilitated for Hallett Dock Company using Acotec's Humidur coating and DZI cofferdam.

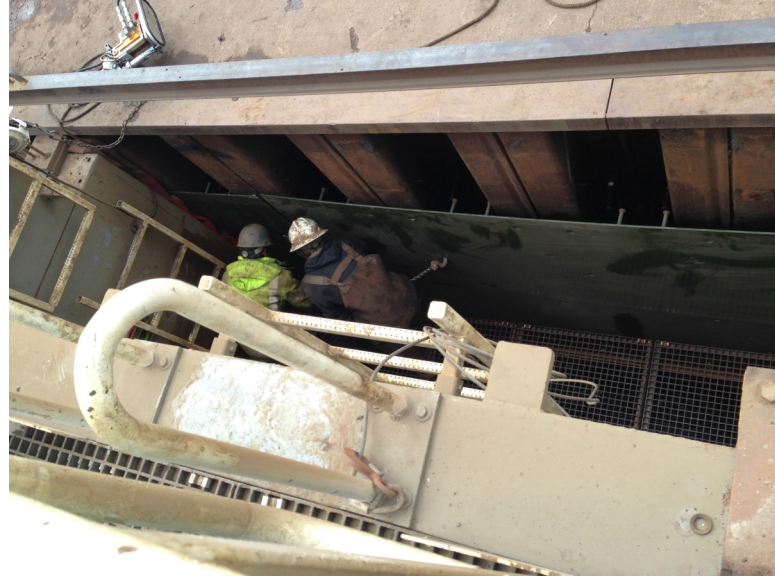
Installation of pre-coated steel plates by means of Acotec's DZI cofferdam

Over 12,000 square feet of corroded sheet pile wall was covered with pre-coated steel plates. The voids between the protection plates and the existing piling were filled with stud-reinforced cement grout and sealed with marine epoxy grout. Additionally, 1,200 feet of new timber fenders were installed.

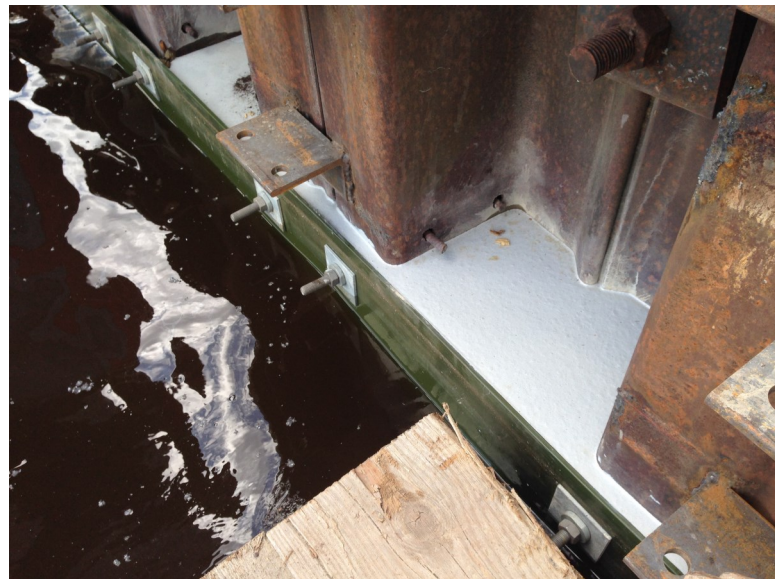
Rehabilitation of severely corroded sheet pile wall with steel plates coated with Humidur
